# CUSTOMER SERVICE BULLETIN

**Date:** May 10, 2023  
**CSB No.:** 2023-02 R1  
**Title:** CSB 2023-02 SPMDe Version Assembly  
**Affected Products:** PN: 160755 and 160755-2 Received Before 03/31/2023

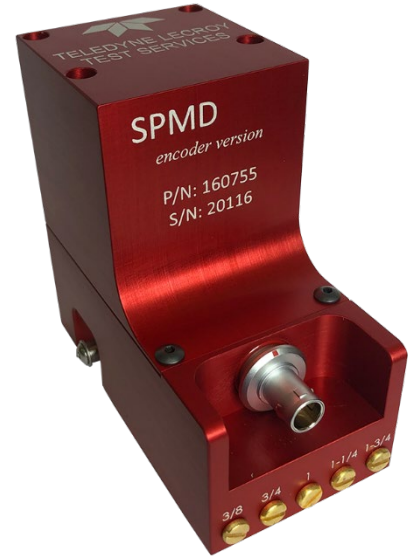
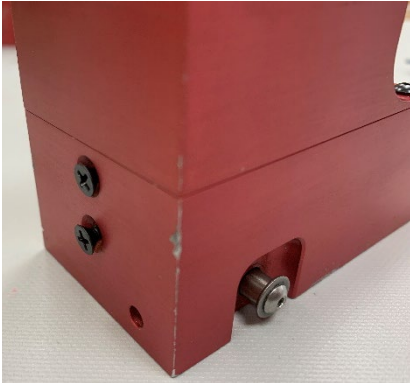
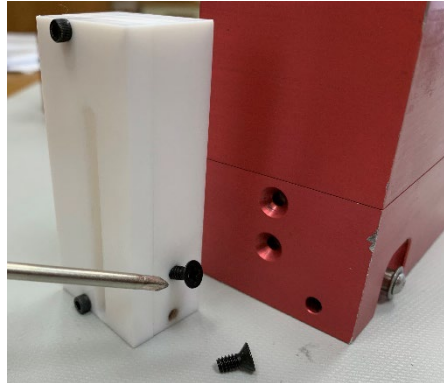
A deficiency was discovered with the Spring Pack Measurement Device Encoder (SPMDe) sensors that allowed for possible misalignment of the displacement rod. Under certain conditions, the threaded fasteners between the internal encoder assembly and the housing become loose.

When retightening these fasteners, it is possible to strip the internal threads. If the housing is not fastened properly, the encoder assembly could become misaligned causing an out of tolerance condition with the linear measurements. Observations during extensive testing is that the loose threads cause a high non-linearity with the output. It appears obvious from the output that there is some type of mechanical failure.

TLTS has redesigned the SPMDe to permanently eliminate this issue and requests that you send back these units for repaired and recalibrated. For technical questions regarding this notice, contact Michael Laperriere by email.
